Nordson MEDICAL
3325 South Timberline Road
Fort Collins, CO 80525, USA

Product Change Notification

Product Change #: PCN311

Posting Date: October 6, 2015

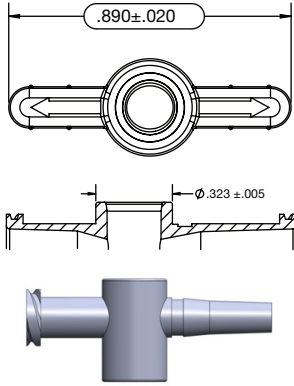
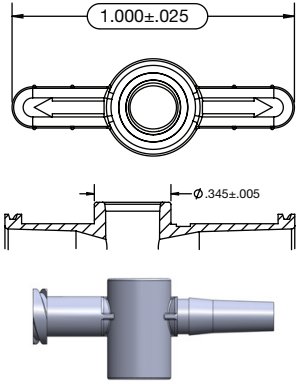
Assemblies Affected	Change Description	Before Image	After Image
FCFM-010	<p>Diverter: Increase the length of the diverter handle to 1.000+/- 0.025" to match VP standards.</p> <p>Body: We are increasing the OD of the body barrel to 0.345 +/-0.005" to match VP standards. The side ports will have core outs to prevent sink on the ID.</p>

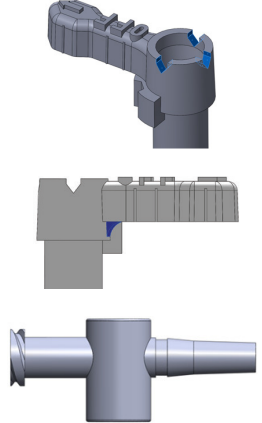
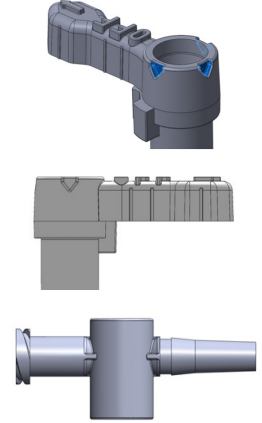
FC4FFMR-001 FCA024-001 FCA024-002 FCFFM-002 FCFFM-1A-003	<p>Diverter: Flow direction indicator notches on the top of the diverter are causing flash, we will be adding a web to that feature. We will be removing a radius on the bottom of the handle as it creates a sharp feature on other parts since the steel is shared with other diverter SKUs.</p> <p>Body: The side ports will have core outs to prevent sink on the ID.</p>

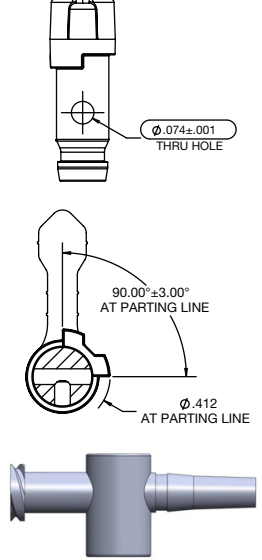
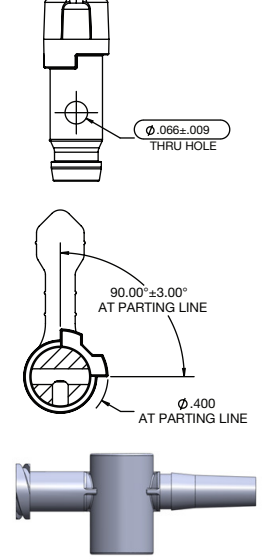
FCA022-001	<p>Diverter: The through bore tolerances will be adjusted to 0.066 +/- 0.009" to match VP large bore standards. Reduce diameter of gate pad/rotation stop to 0.400 +/- 0.005" to match VP standards.</p> <p>Body: The side ports will have core outs to prevent sink on the ID.</p>

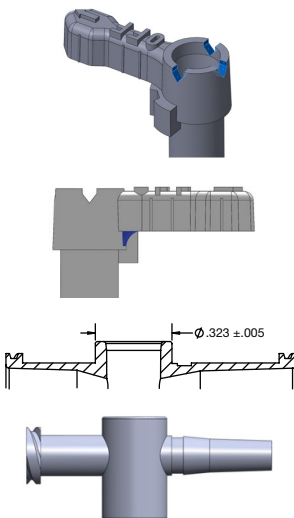
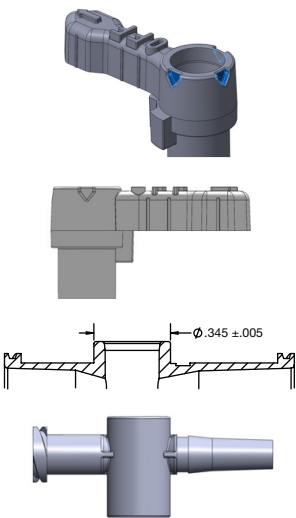
Assemblies Affected	Change Description	Before Image	After Image
FCA010-001 FCA012-001 FCA026-001 FCA028-001 FCA040-001 FCA047-001 FCFFM-003 FCFFM-008 FCFFM-009 FCFFM-010 FCFFM-013 FCFFM-014 FCFFMR-002 FCFFMR-003 FCFFMR-004	<p>Diverter: Flow direction indicator notches on the top of the diverter are causing flash, we will be adding a web to that feature. We will be removing a radius on the bottom of the handle as it creates a sharp feature on other parts since the steel is shared with other diverter SKUs.</p> <p>Body: We are increasing the OD of the body barrel to 0.345 +/-0.005" to match VP standards. The side ports will have core outs to prevent sink on the ID.</p>

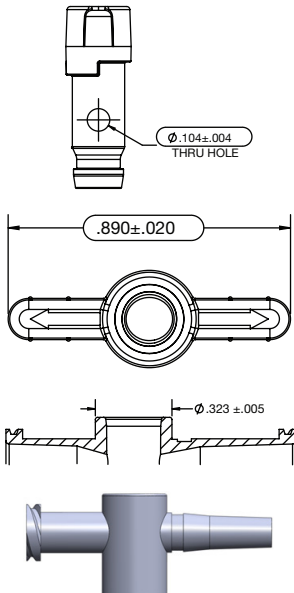
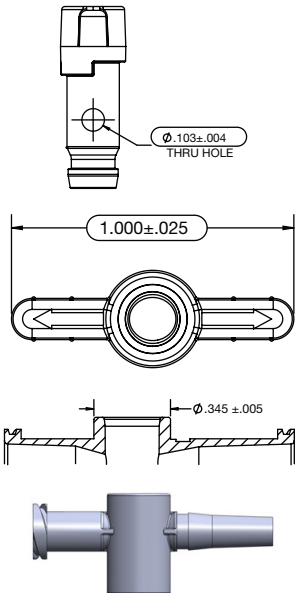
FCA019-001 FCLBFMR-001	<p>Diverter: The through bore tolerances will be adjusted to 0.103 +/- 0.004" to match VP large bore standards. Increase the length of the diverter handle to 1.000 +/- 0.025" to match VP standards.</p> <p>Body: We are increasing the OD of the body barrel to 0.345 +/-0.005" to match VP standards. The side ports will have core outs to prevent sink on the ID.</p>
